# Subglacial lake in the glacier of Tete Rousse (Mont Blanc area, France)

C. Vincent (1), A. Legchenko (2)

20 Avril 2011  
Grenoble

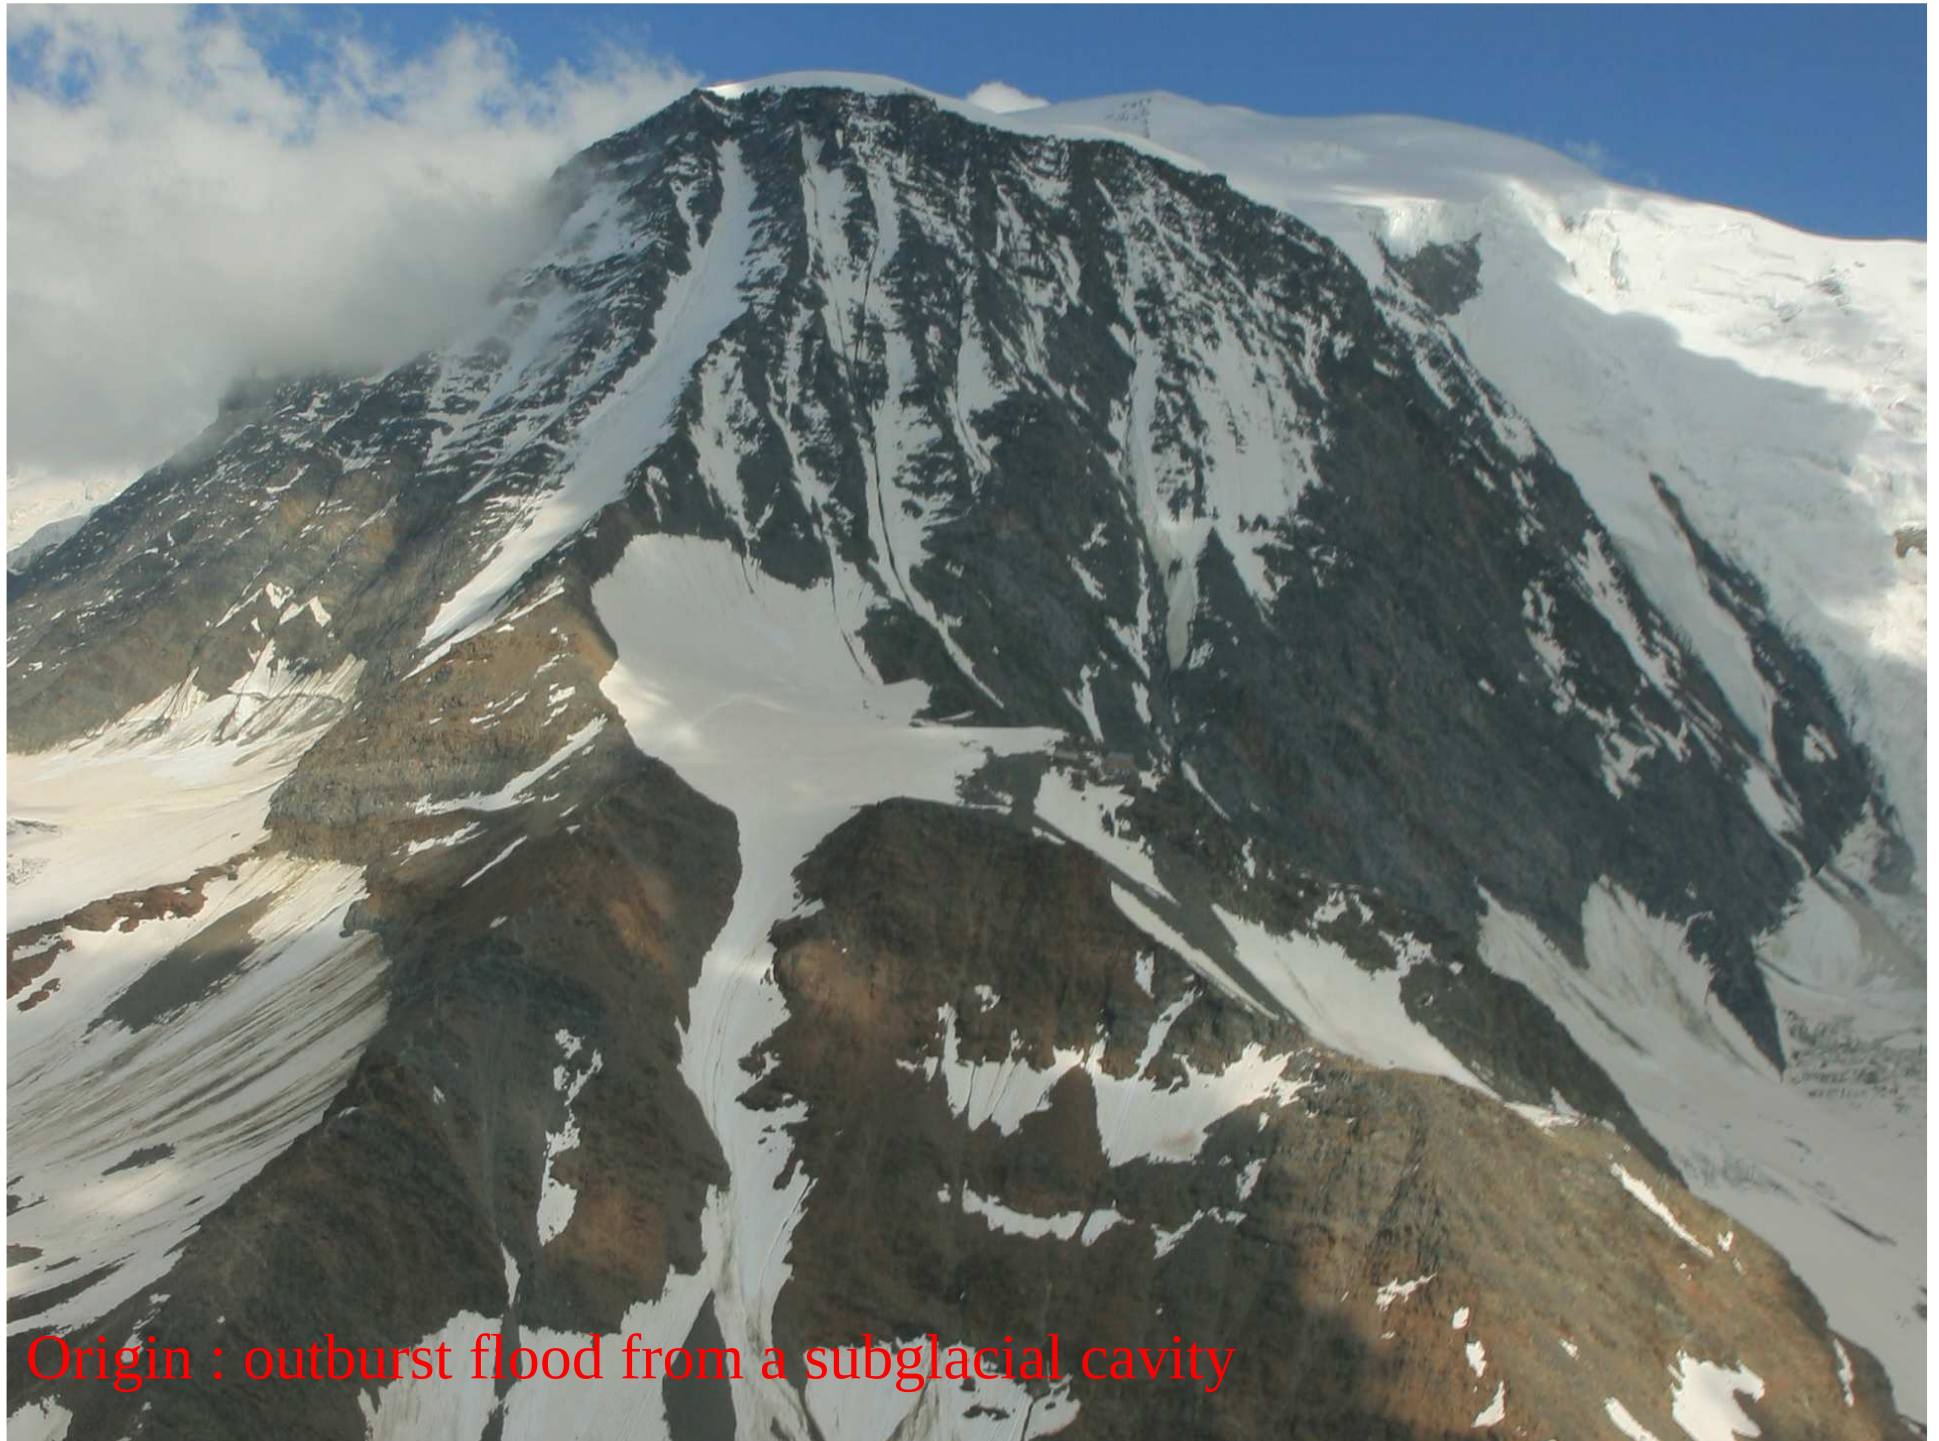
Fig. 22. — Le pont de la route départementale n° 4 tourné et submergé par la lave.  
13 juillet 1892. — Cliché Kuss.

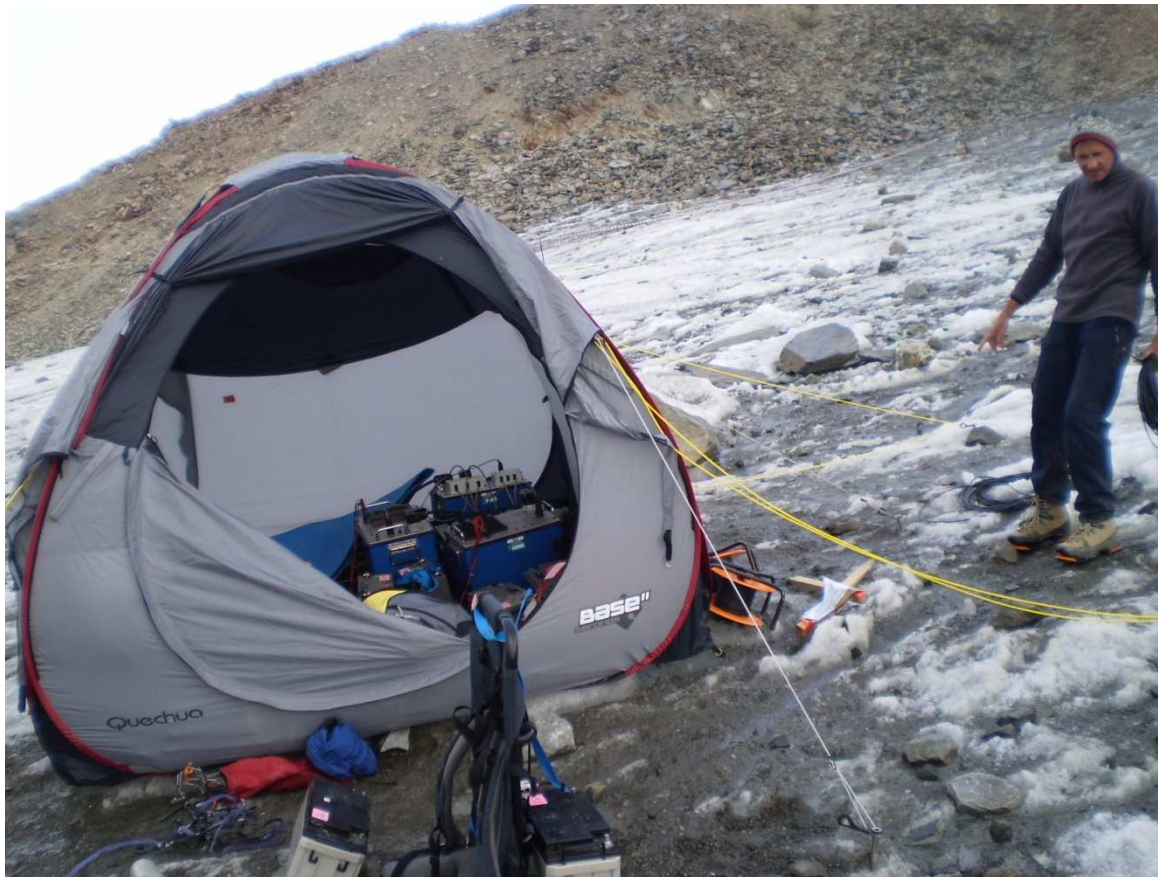
**Prospection géophysique par la méthode de résonance magnétique**

Water content (%)

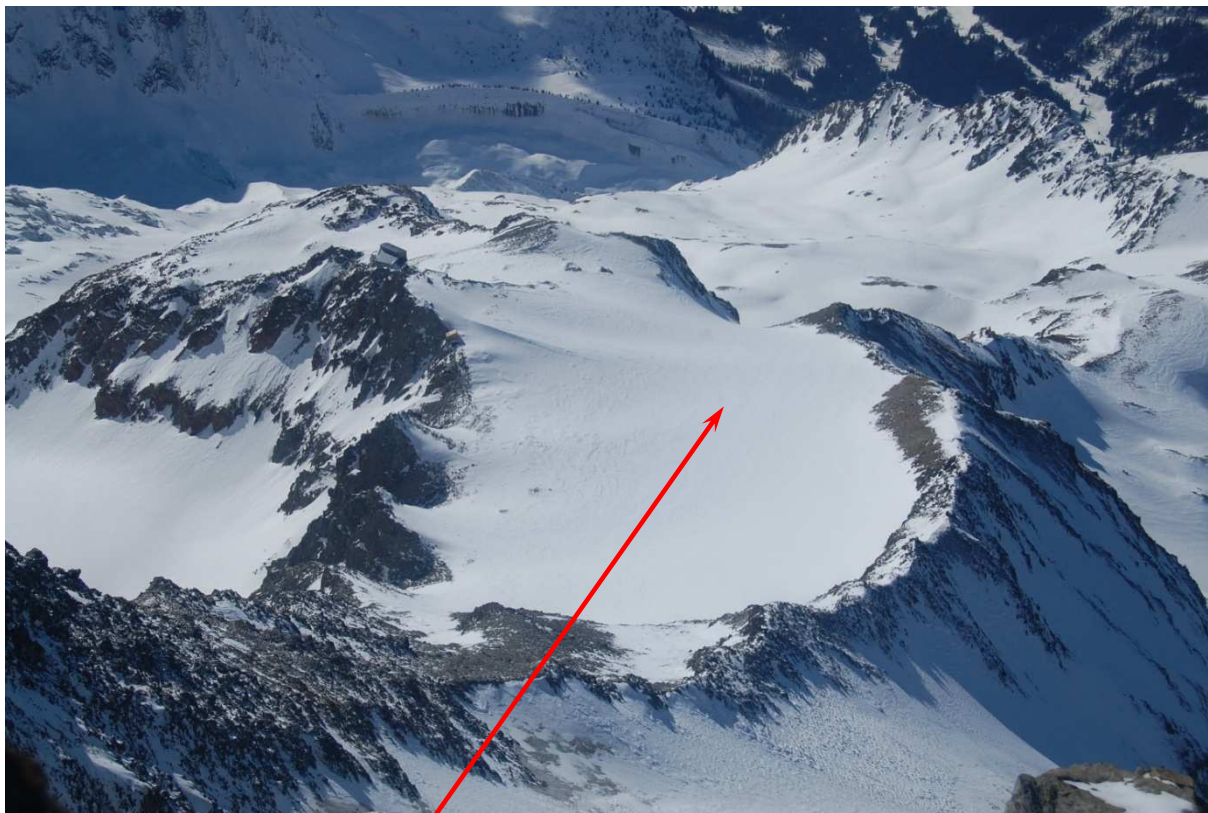
Volume d'eau de 65 000 m<sup>3</sup>

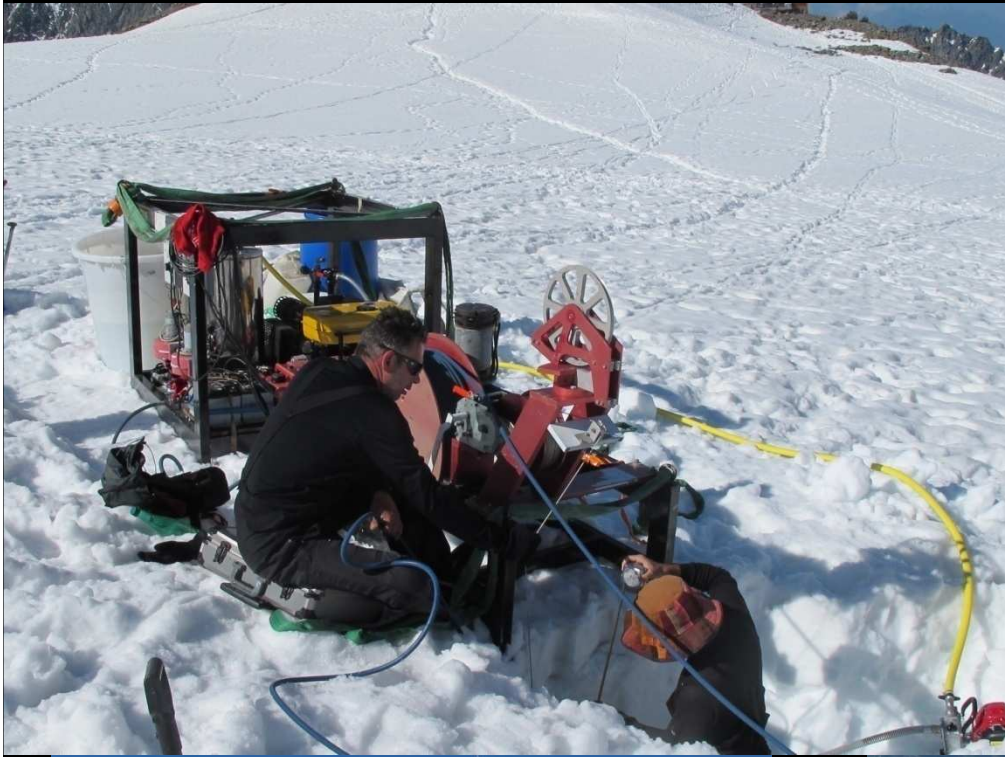
20 drilling holes have been performed between the 29 of June and the 8 of July, 2010 using a thermal drilling machine,

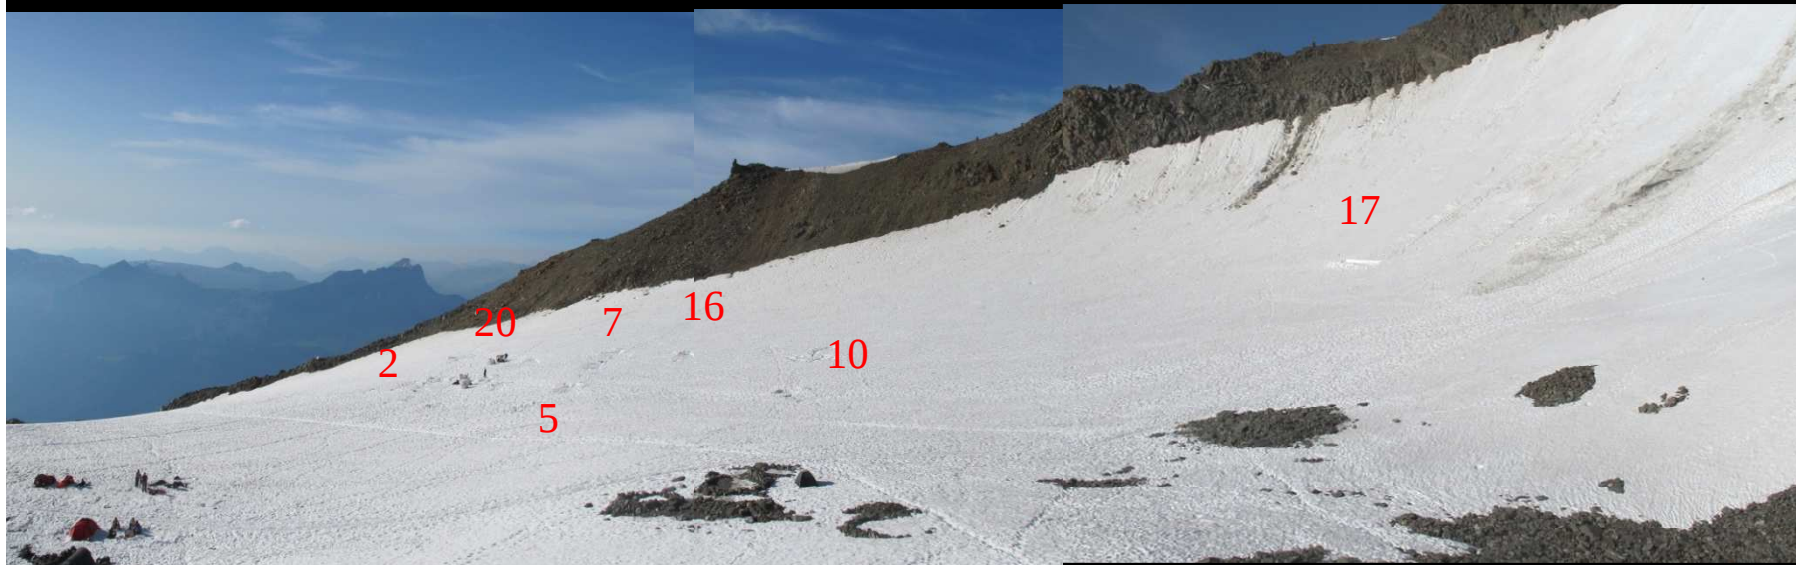
**. 20 drilling holes**

**. Maximum thickness is 76 m**

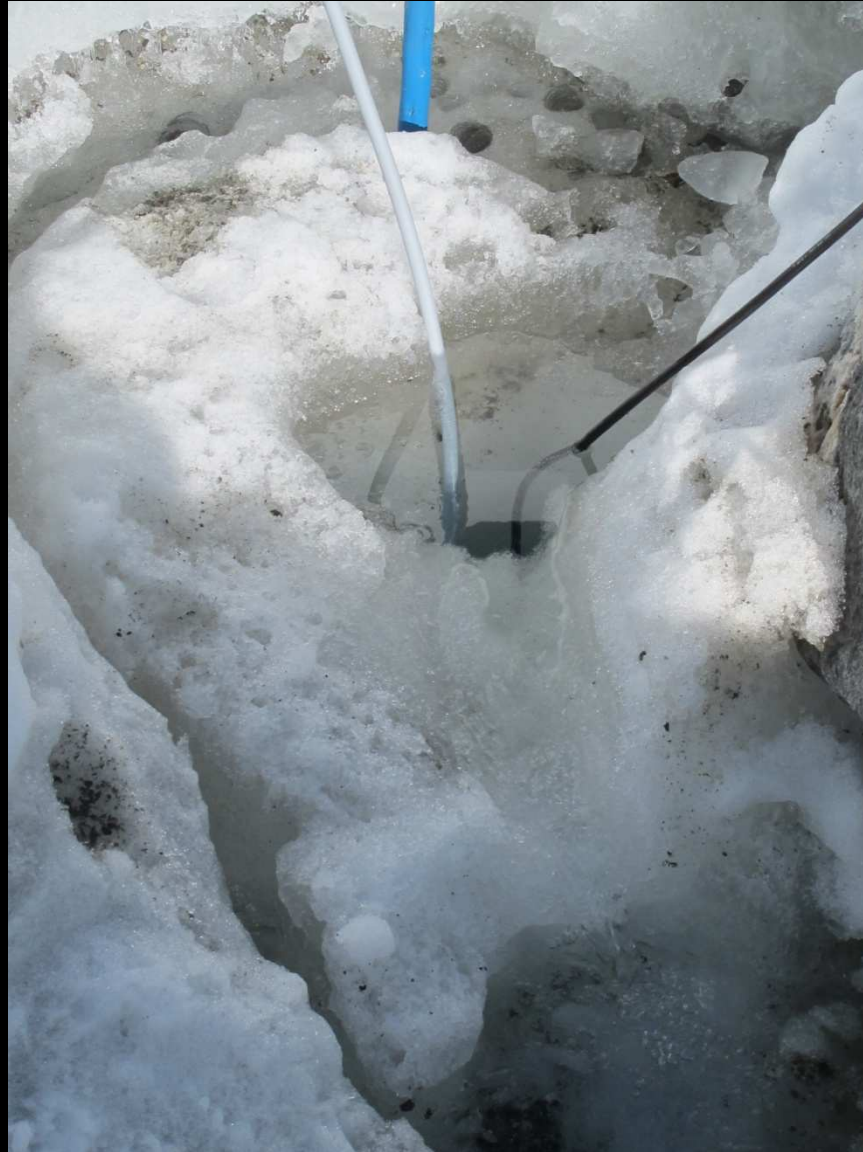
We found a subglacial water reservoir at the bottom of 6 boreholes  
(Video)

At 2 boreholes, artesian outpourings 10 cm higher than the ice surface occurred when the subglacial cavity was reached

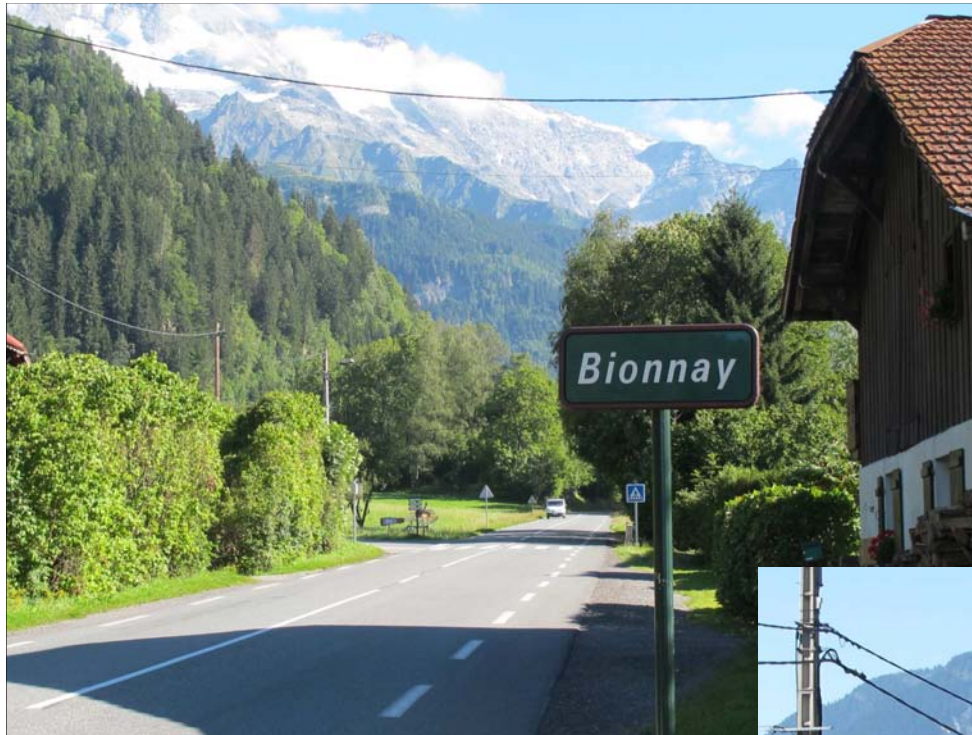
Alert system set up to trigger off fire sirens in the villages downstream

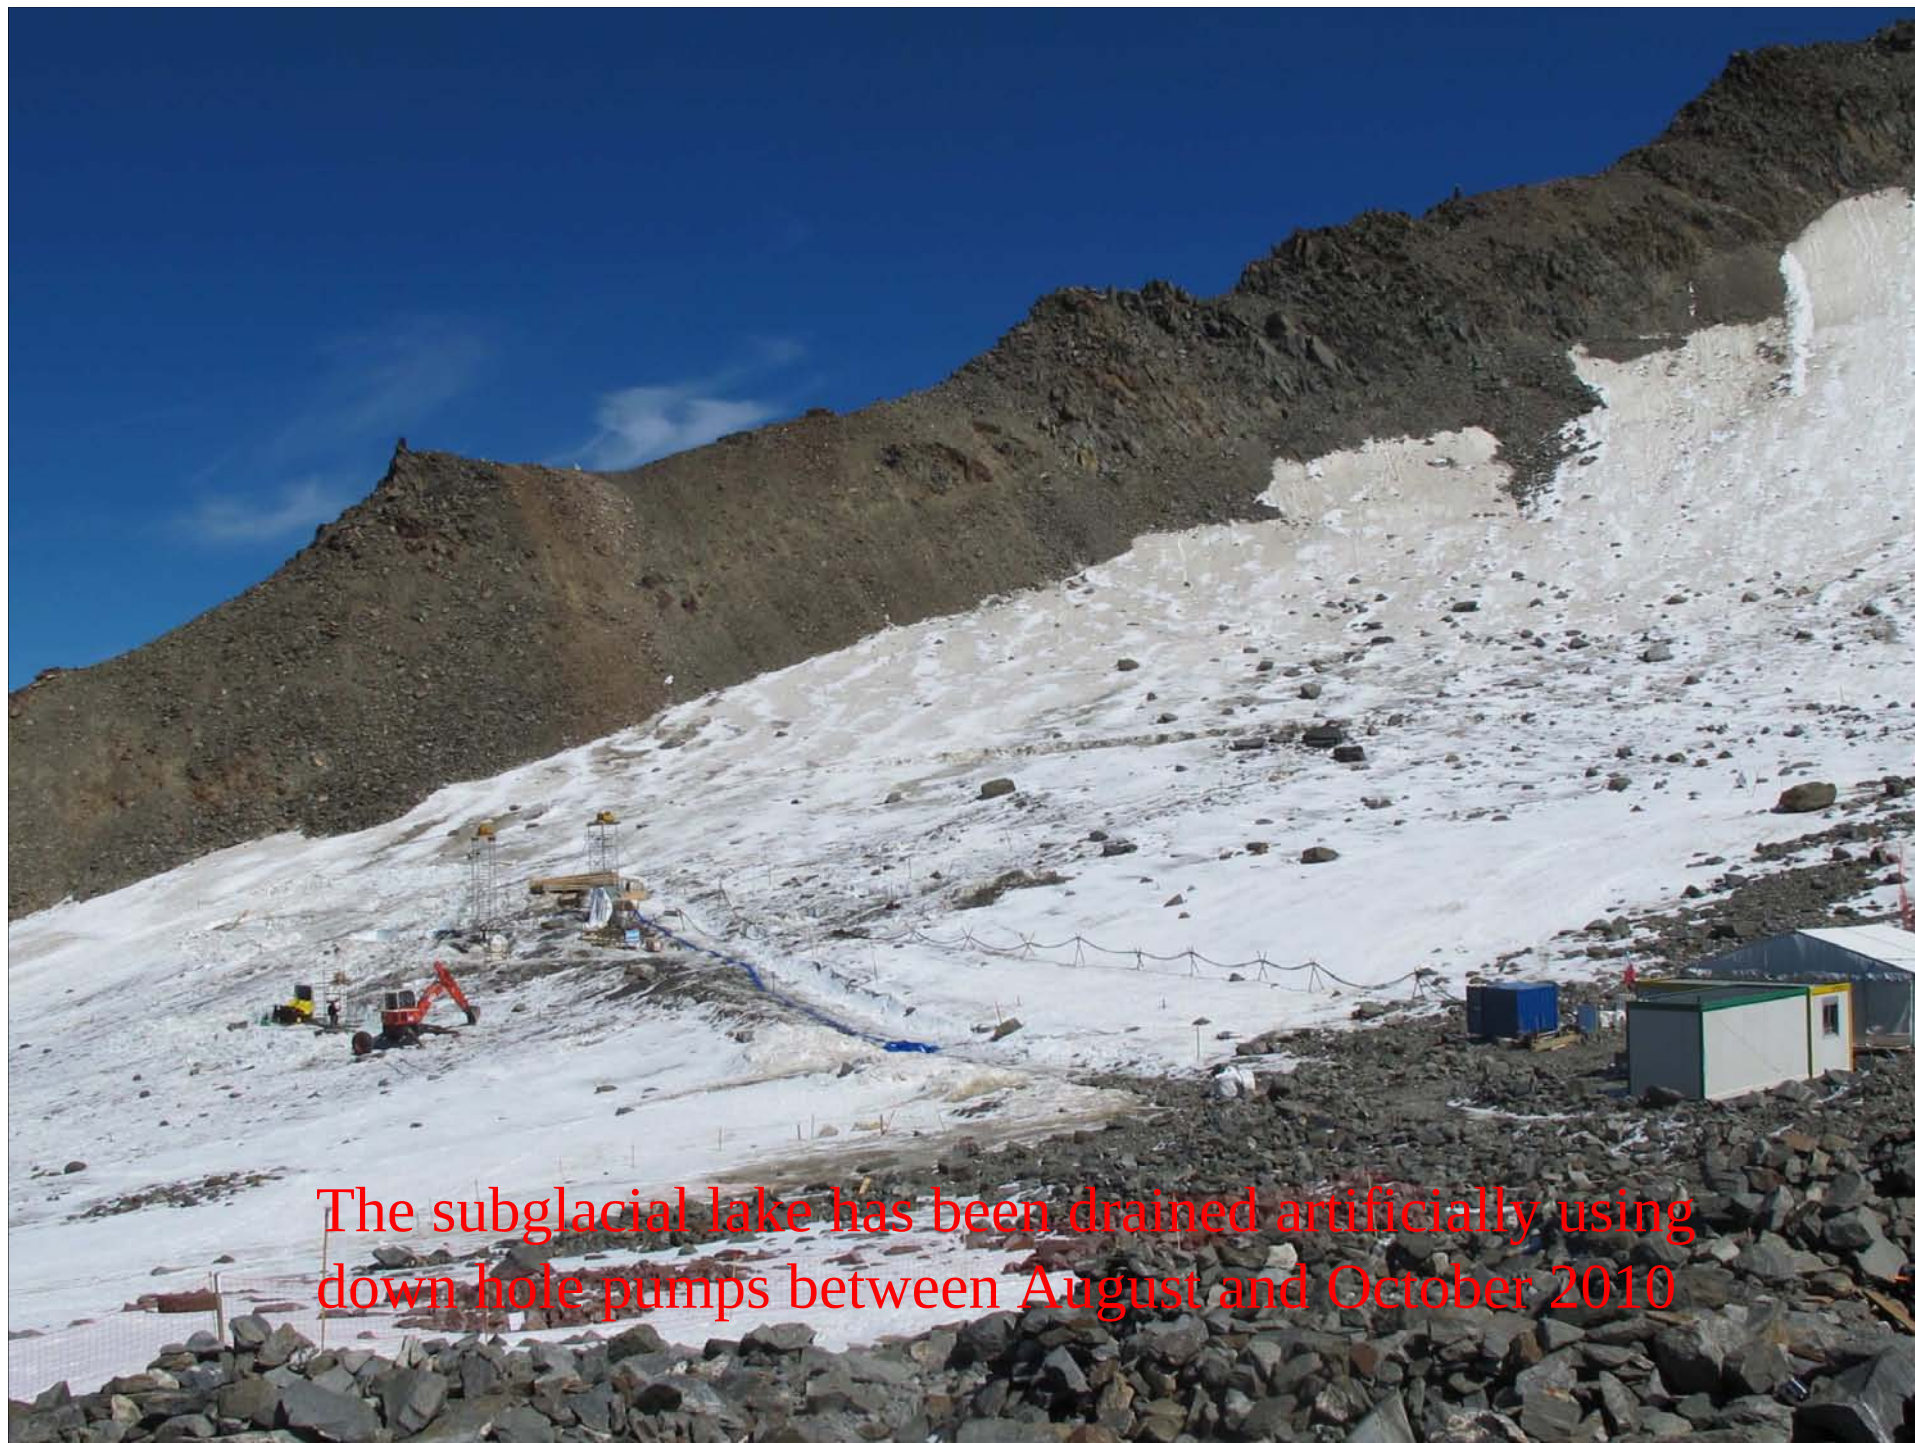
The subglacial lake has been drained artificially using down hole pumps between August and October 2010
